**ISSUE**

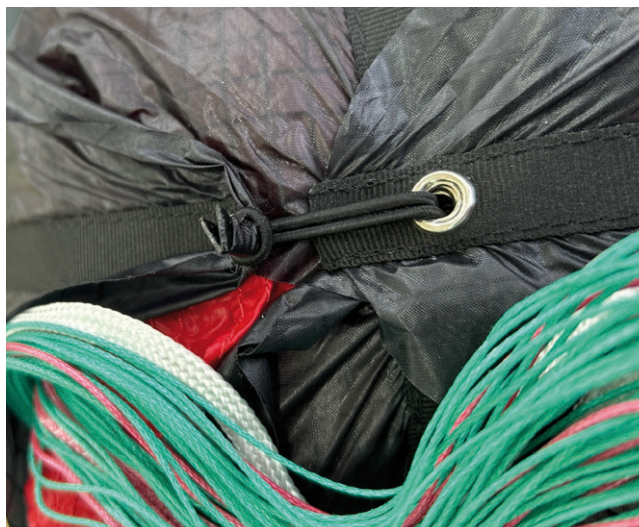
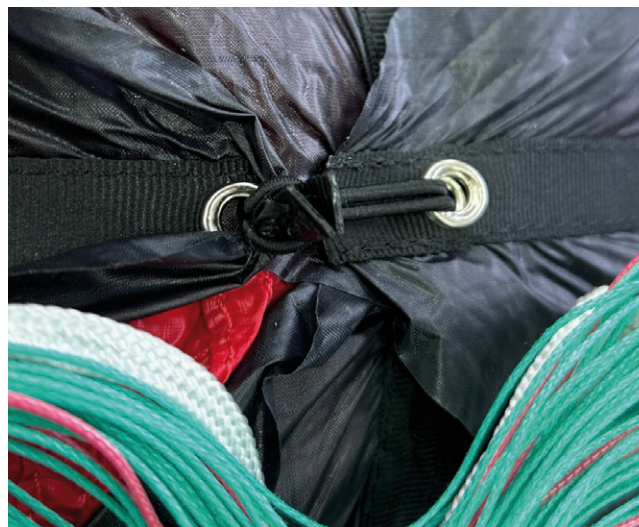
During a simulated rescuer throw of a TAPA X-ALPS (size 105), a small piece of the fabric from the inner container was caught by the retrieval lines. As shown in the image below on the right, the fabric piece was pulled into the elastic line loop. Despite releasing the retrieval line package, the inner container remained blocked by the fabric piece and remained closed.

skywalk promptly and comprehensively examined this scenario. The cause could have been a packing error. Nevertheless, skywalk has chosen to release a safety notice to eliminate any risk for the pilots.

The inner container can be quickly and easily revised. The excess fabric on all 4 edges of the inner container will be removed by 5mm after the eyelet. As a customer, you have several options for implementing this:

1. Your skywalk dealer can handle this for you quickly and easily after consultation. Ideally, this can be done directly on-site, and you can wait for it.
2. Your importer in your country can perform the repair.
3. If you don't have either of these contacts in your vicinity, please contact skywalk directly. We will then discuss with you where you can have the revision done most quickly.
