BREEZE2 SAFETY NOTICE

When installing the reserve system in the BREEZE2, the two white loops are threaded through the eyelet using a packing loop and then secured with the split pin system of the reserve handle.

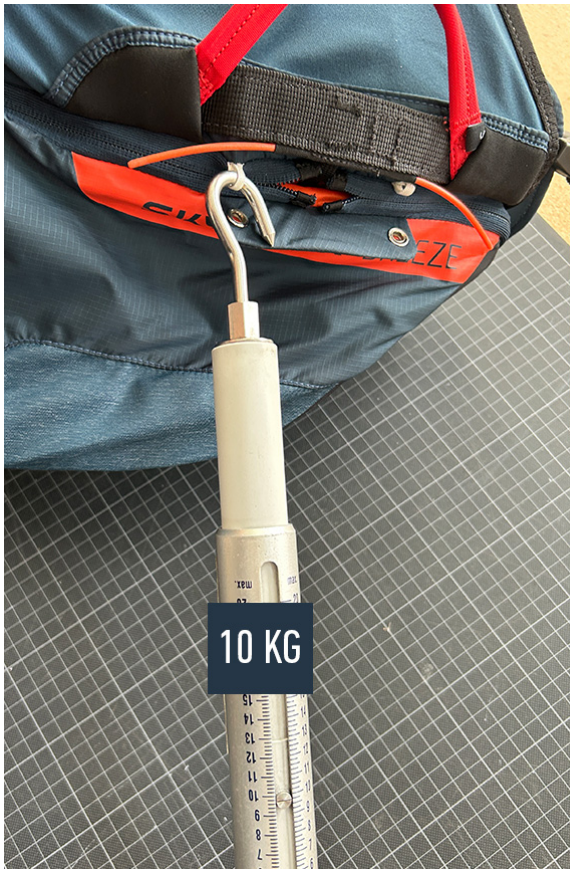
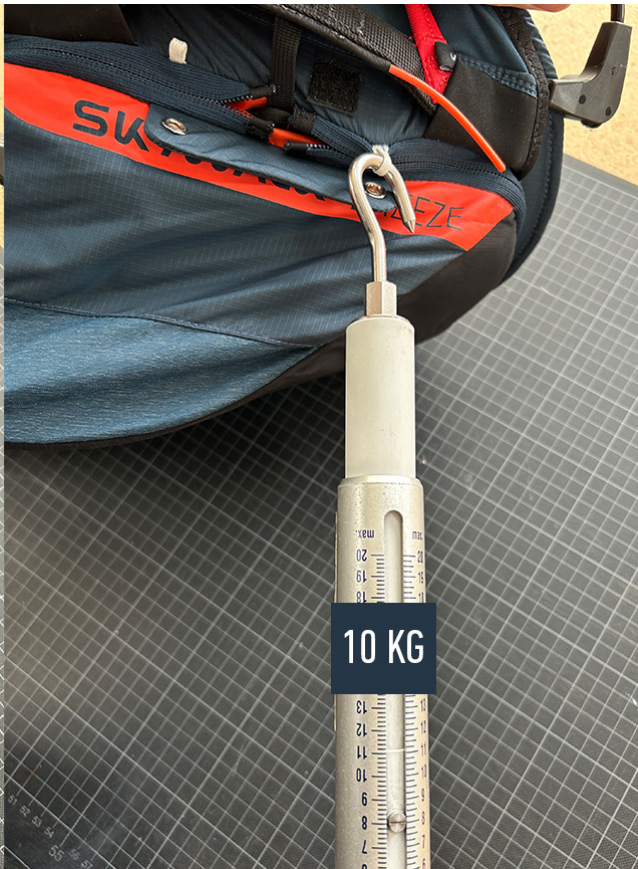
2. Tensile test on both rescue loops with 10 kg each.

If one of the white loops breaks during the tensile test and you consequently have a harness affected by the safety notice, please contact our support team immediately. You can easily reach them at support@skywalk.org or via the phone number listed below.

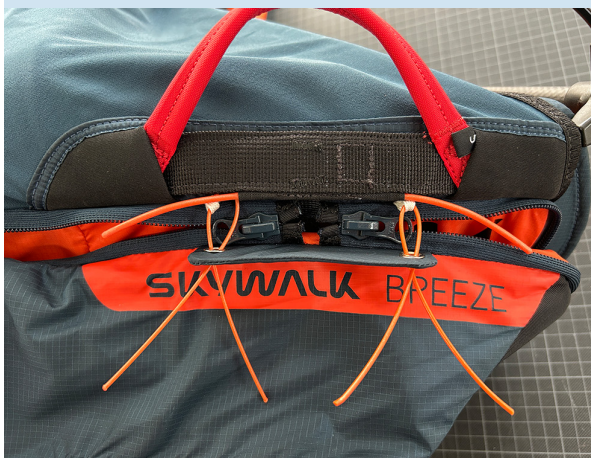
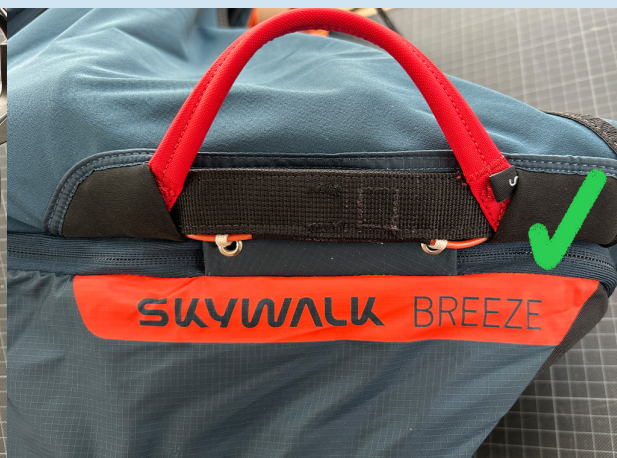
3. Follow the instructions in the manual for the rescue system installation.
